# Manhole Inspection Summary

Manhole # S1100\_003MH

Insp Date: **8/15/07 12:57 PM**

**Location** Address: **3200 PIEDMONT AVE**

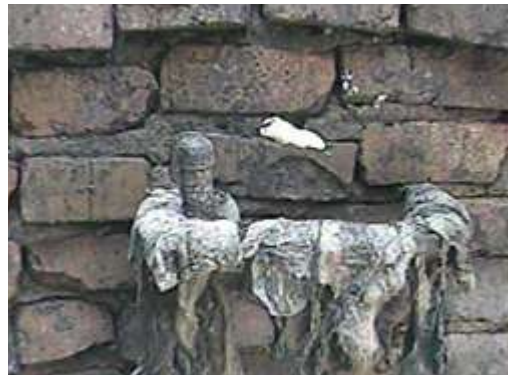
Defect 1

☒ **Evidence Of Surcharge** Depth: **3** (ft.) ☐ Active Surcharge Present

EVIDENCE OF SURCHARGE

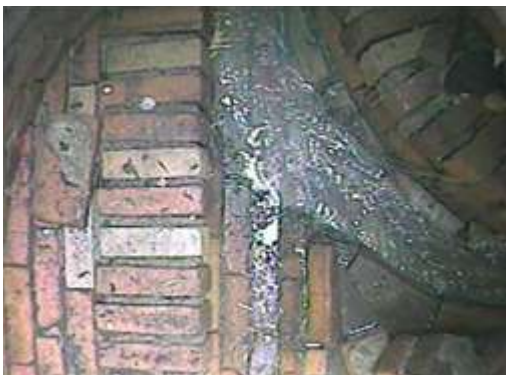
Defect 2

Condition: ☐ Sound ☒ **Cracked** ☐ Root Intrusion ☒ **Deteriorated** ☐ Leaks ☐ Debris

BENCH DETERIORATED

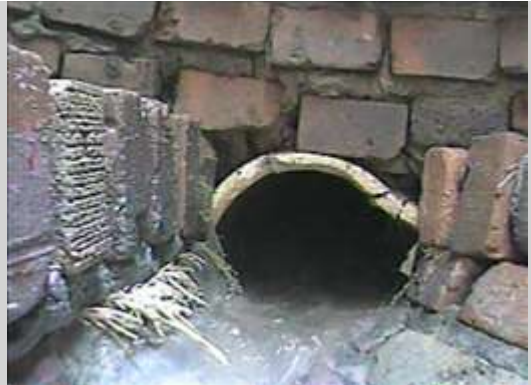
12 O'Clock Outflow

8 in. Circular Gravity Sewer  
Pipe Out @ 12 O'Clock

Infiltration: **None** Pipe Seal Cond: **Broken**

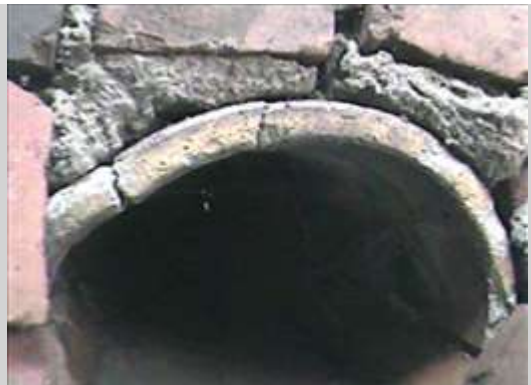
3 O'Clock Inflow

8 in. Circular Gravity Sewer  
Pipe In @ 3 O'Clock

Infiltration: **None** Pipe Seal Cond: **Broken**

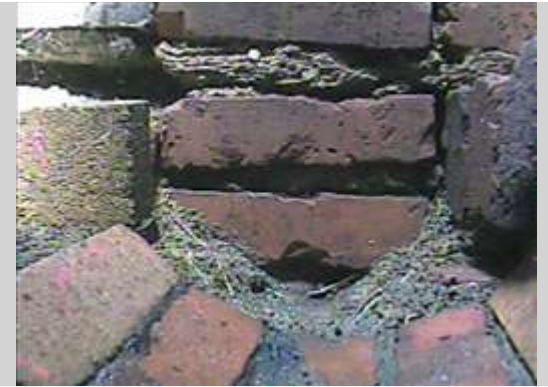
6 O'Clock Inflow

Connects To: **Stub connection / abandoned**
